HUD MAP CAPITAL NEEDS ASSESSMENT

Franklin Towers
50 White Street
Tarrytown, New York 10591

AEI Project No. 419363
Site Inspection Date: 3/10/2020

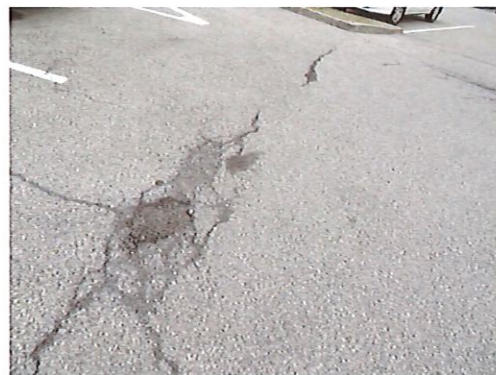
Pothole Repair for Asphalt Parking Lot (Non-Critical Repair)

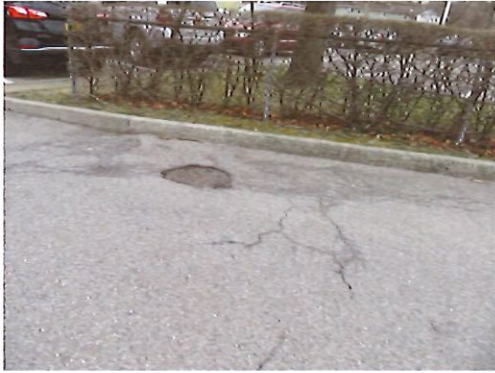
Pothole Repair for Asphalt Parking Lot
(Non-Critical Repair)

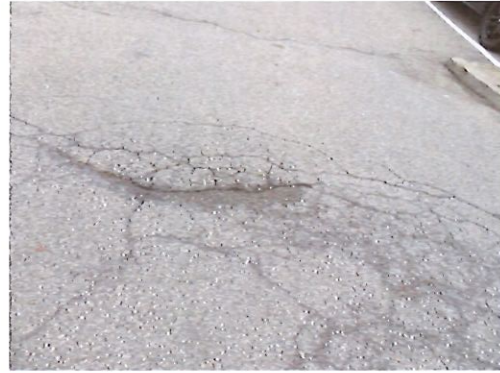
Pothole Repair for Asphalt Parking Lot
(Non-Critical Repair)

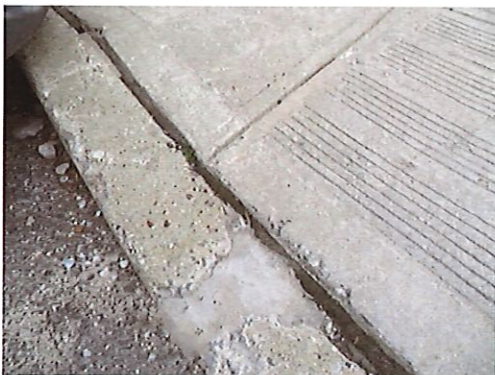
Cracking Ramp Concrete (Critical Repair)

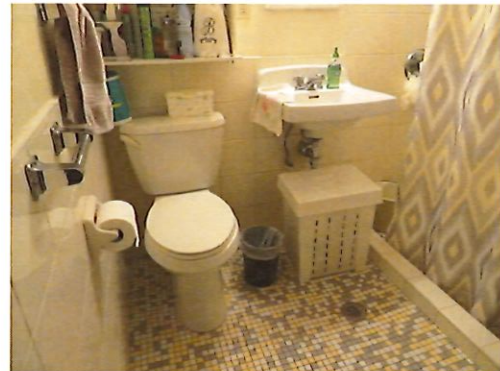
UFAS Unit 103 Two Bedroom One Bathroom (occupied): Bathroom Needs Grab Bars (Critical Repair)

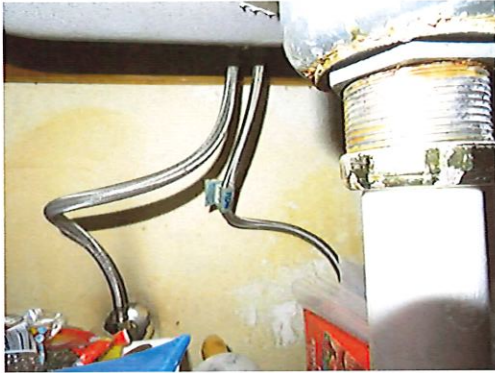
UFAS Unit 103 Two Bedroom One Bathroom (occupied): Sink Under Counter Not Prepped For Wheelchair (Critical Repair)

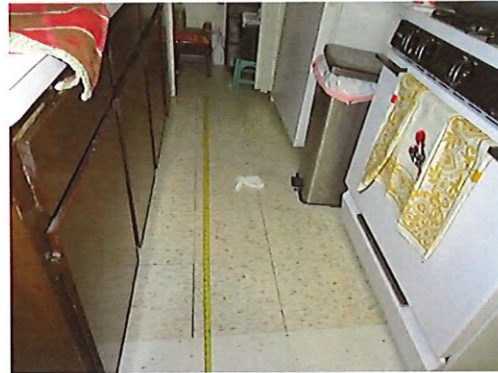
UFAS Unit 103 Two Bedroom One Bathroom (occupied): Kitchen Width is less than 40-inches (Critical Repair)

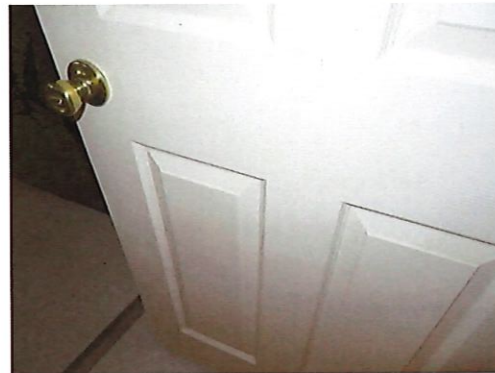
UFAS Unit 103 Two Bedroom One Bathroom (occupied): Bathroom Door Doesn't Have Levered Hardware (Critical Repair)

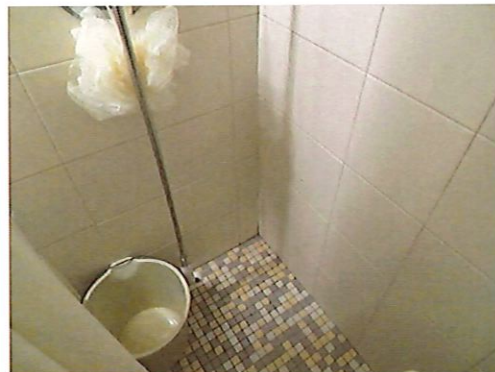
UFAS Unit 103 Two Bedroom One Bathroom (occupied): Shower Hose Broken (Critical Repair)

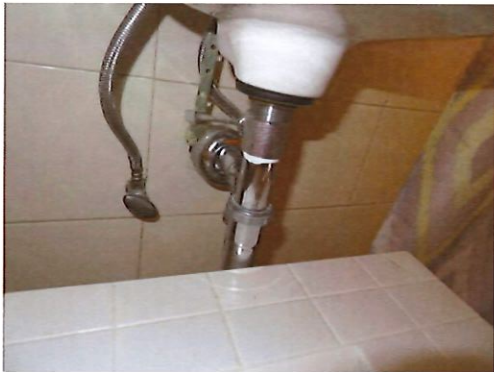
- The designated handicapped dwelling unit bathrooms were observed without scald and abrasion wrapping installed at the sink piping, which is required in order to comply with UFAS and for the safety of the residents. (Critical Repair)
- The designated UFAS units bathroom and bedroom doors were equipped with knob hardware. In order to comply with UFAS, levered hardware is required to be installed. (Critical Repair)
- Concrete flatwork was observed adjacent to the play area, but no pavement was provided directly connecting to the play area, which is required in order to comply with UFAS. (Critical Repair)

UFAS Unit 103 Two Bedroom One Bathroom (occupied): Bathroom Sink Needs Scald and Abrasion (Critical Repair)

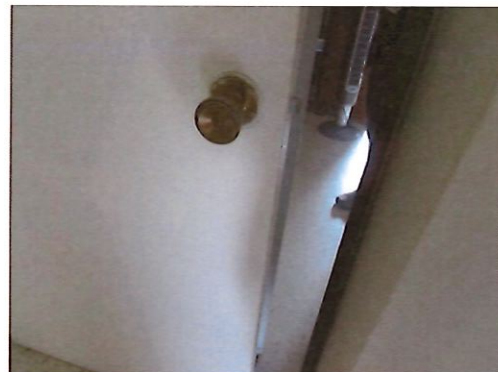
UFAS Unit 103 Two Bedroom One Bathroom (occupied): Bedroom Does Not Have Levered Hardware (Critical Repair)

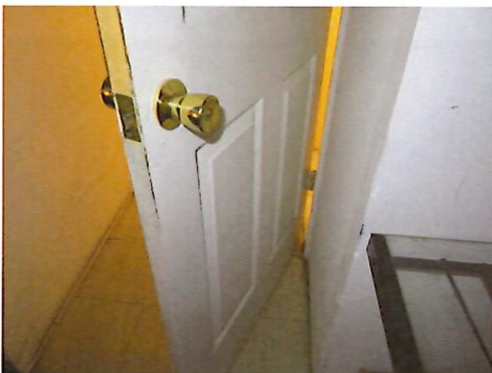
UFAS Unit 22 Two Bedroom One Bathroom (occupied): Bathroom Door Not Handicap Lever (Critical Repair)

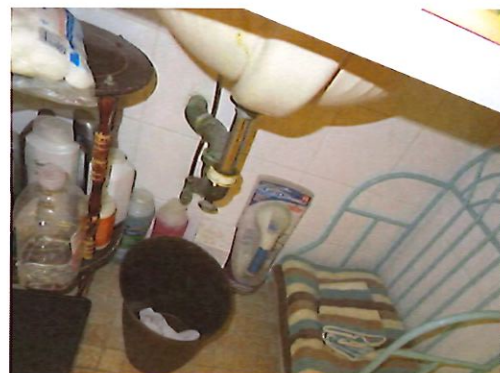
UFAS Unit 22 Two Bedroom One Bathroom (occupied): Bathroom Sink No Scald and Abrasion (Critical Repair)

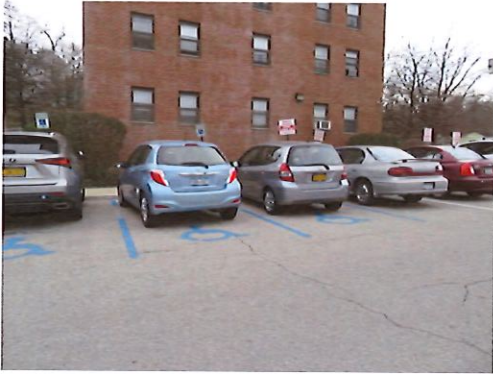
Accessible Parking Near Leasing Office - No access aisles (Critical Repair)

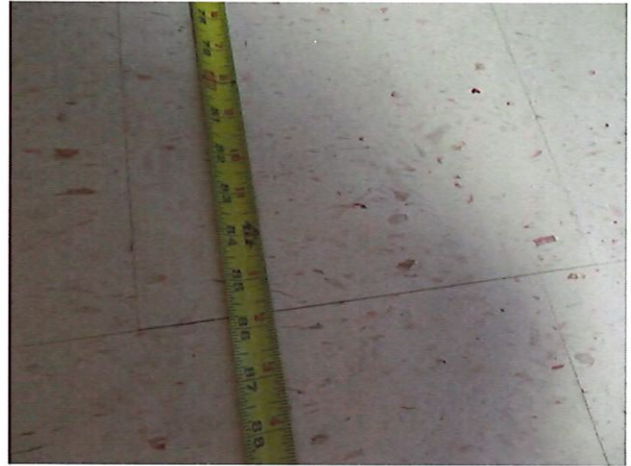
9. UFAS Unit 103 Two Bedroom One Bathroom (occupied): Kitchen Width is less than 40-inches (Critical Repair)

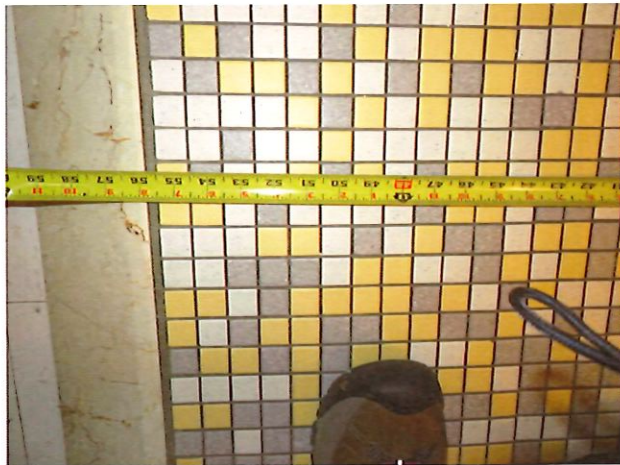
14. UFAS Unit 103 Two Bedroom One Bathroom (occupied): Shower Hose Broken (Critical Repair)

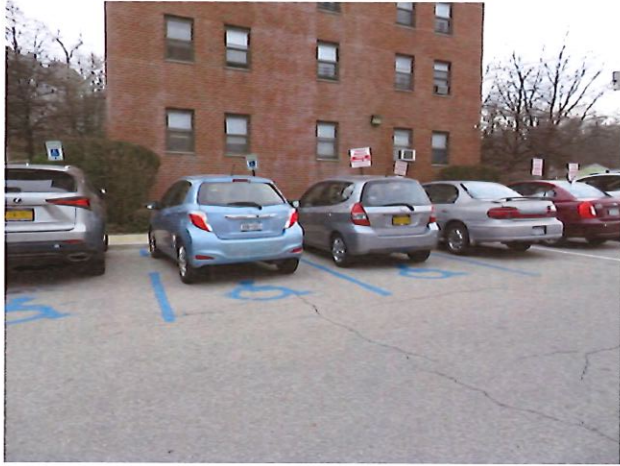
1. Accessible Parking Near Leasing Office - No access aisles (Critical Repair)

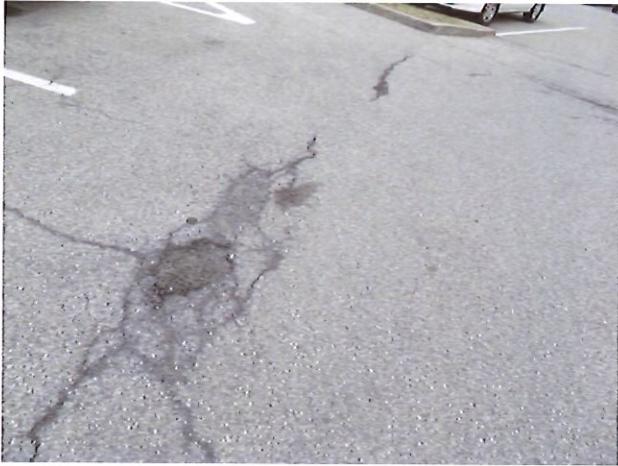
25. Pothole Repair for Asphalt Parking Lot (Non-Critical Repair)

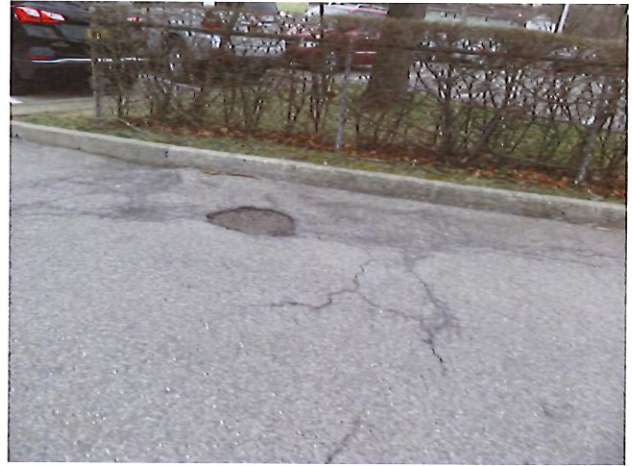
26. Pothole Repair for Asphalt Parking Lot (Non-Critical Repair)

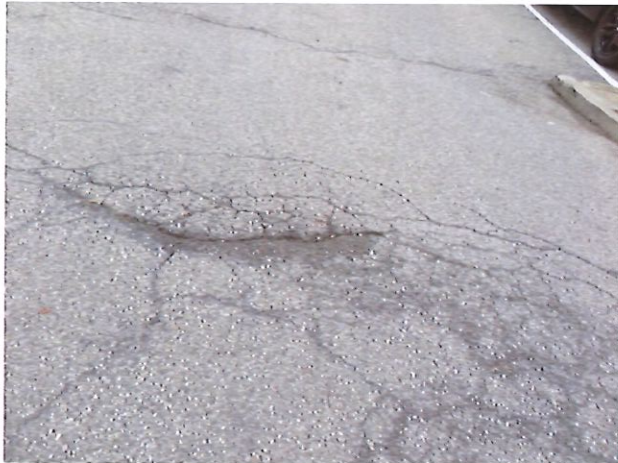
27. Pothole Repair for Asphalt Parking Lot (Non-Critical Repair)

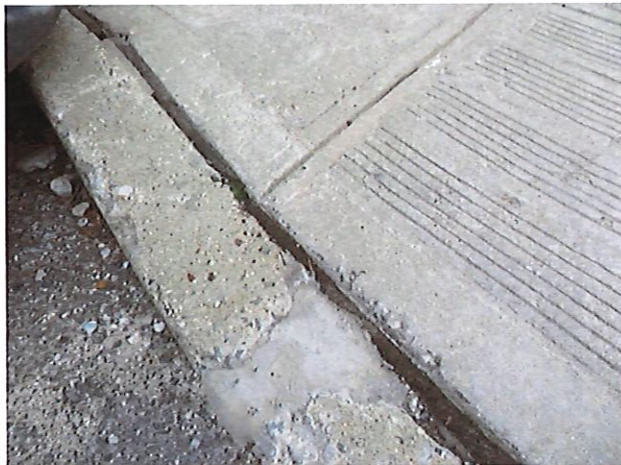
31. Wheelchair Access Way Needs to be Repaired
(Critical Repair)

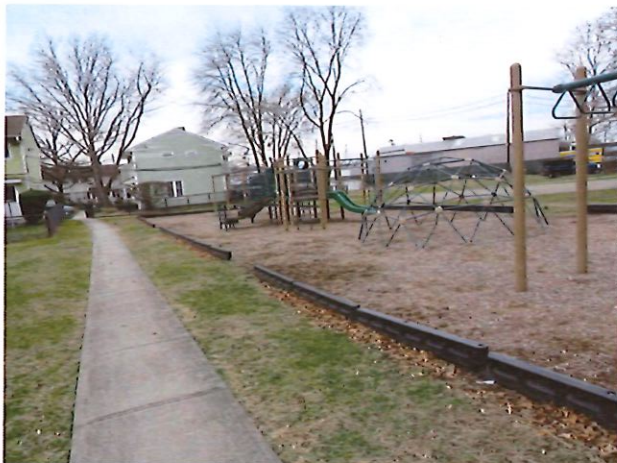
43. Playground Needs Correct Path of Travel to Swings and Slides (Critical Repair)
