HUD MAP CAPITAL NEEDS ASSESSMENT

Franklin Towers
50 White Street
Tarrytown, New York 10591

AEI Project No. 419363
Site Inspection Date: 3/10/2020

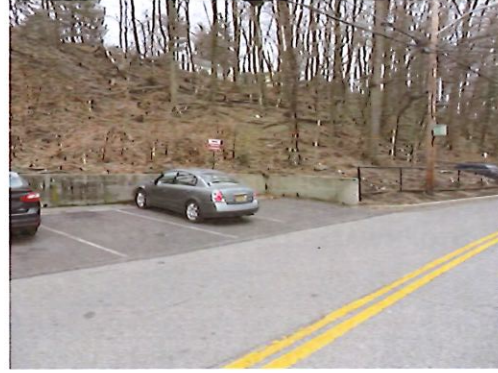
Retaining Wall and Parking Along Franklin Court

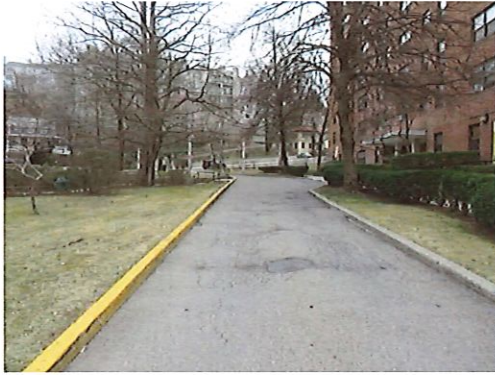
Property Entrance Facing Franklin Street

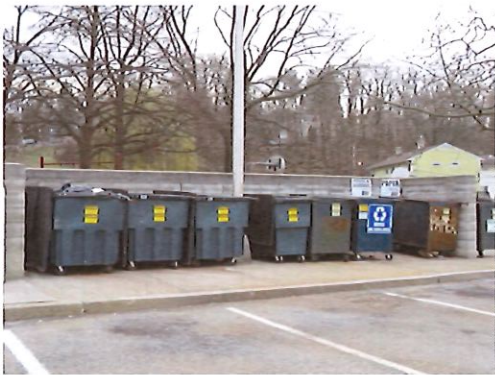
Trash Enclosure by Parking Lot

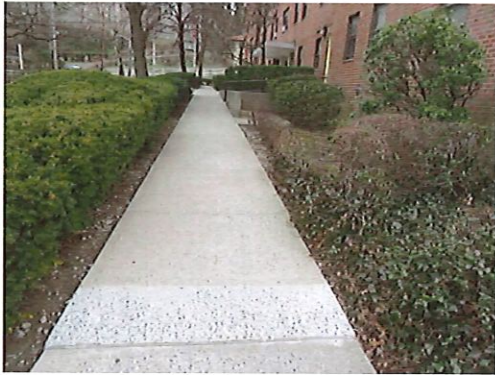
Concrete Sidewalk Near Leasing Office

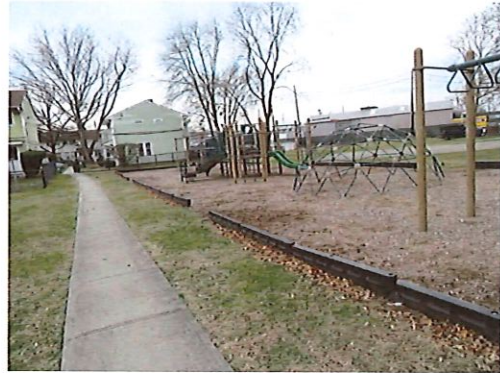
Concrete Sidewalk Near Playground

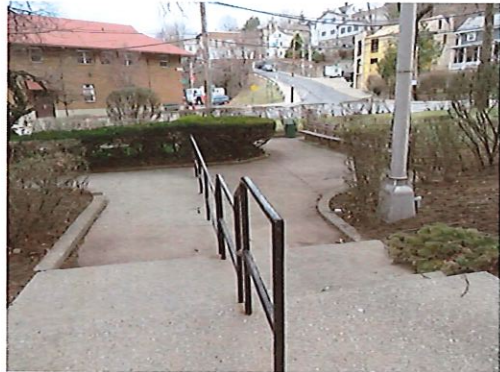
Outdoor Steps and Metal Handrail

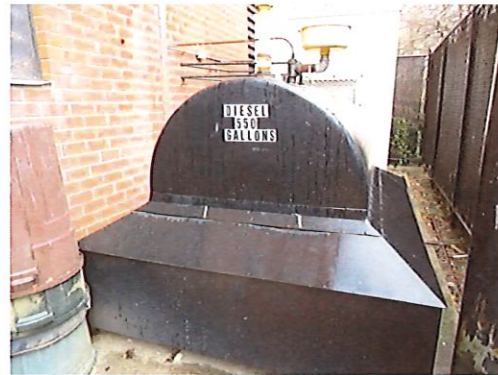
Diesel Tank for Emergency Generator

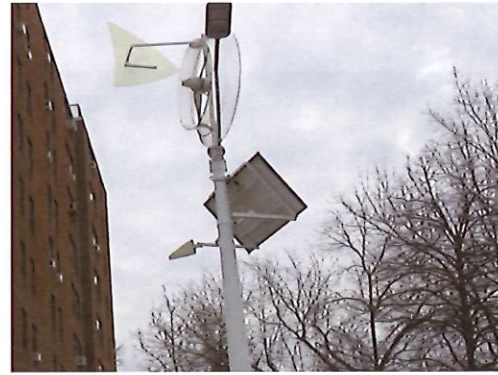
Solar and Wind Generation for Parking Light Fixtures

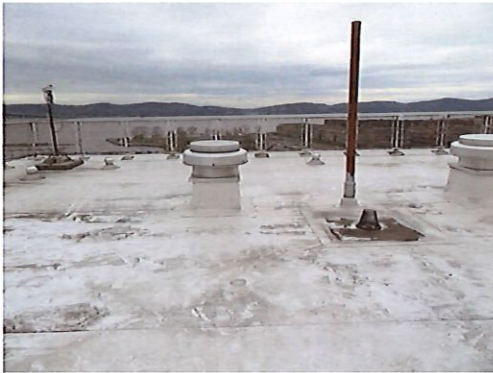
View of Roof

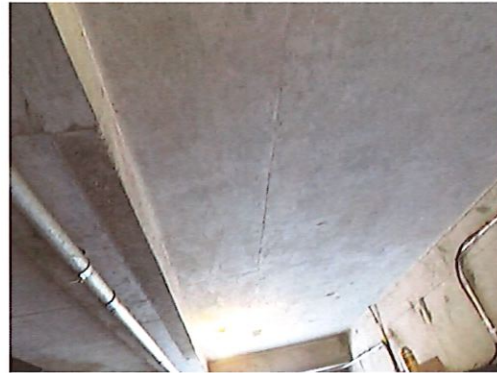
Lightweight Concrete Ceiling

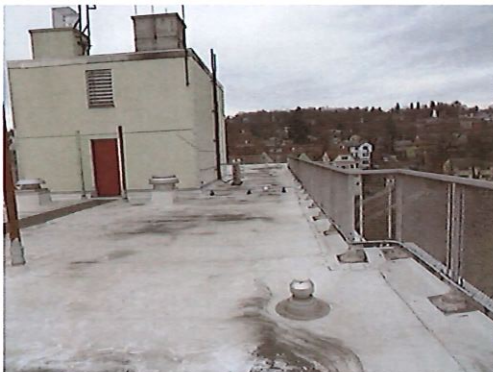
View of Exterior Elevator Maintenance Room

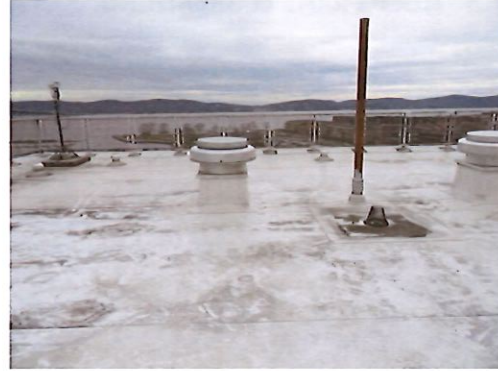
View of Roof

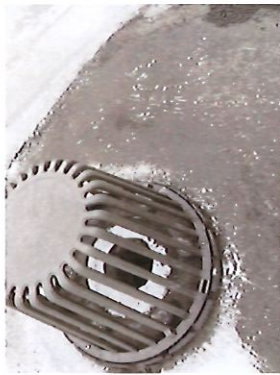
Typical Roof Drain

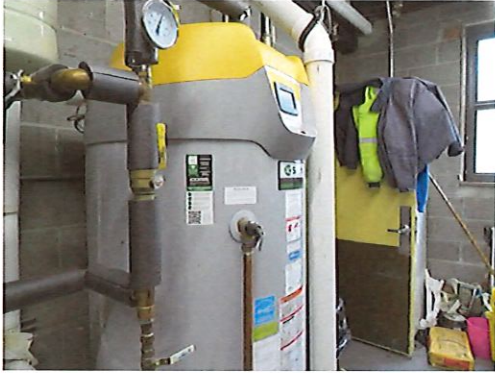
AO Smith Water Heater

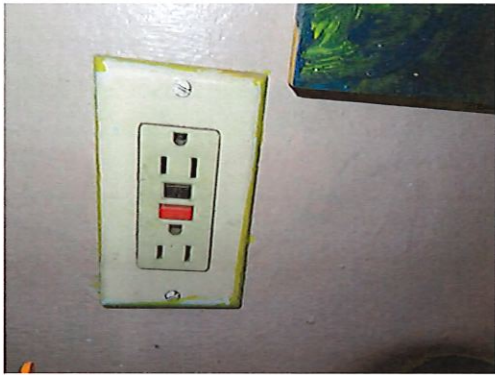
Unit 82 Two Bedroom One Bathroom (occupied): Bathroom GFCI

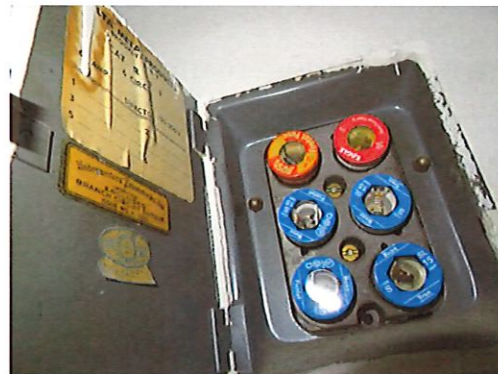
Screw-in Fuse (SL/TL) Panel

The power to the property was reportedly sufficient, however TL and SL fuses were observed. The concern with fused subpanels stems from the configuration of the fuses themselves, which allow for fuses of different ratings to fit into a traditional Edison fuse socket.

The replacement of a blown fuse with a fuse rated for higher amps may result in an unprotected branch circuit, followed by an overload and potential fire. The second concern with Edison sockets is that shunting of open fuses can allow for the insertion of metal objects into the socket as a means to reconnect the circuit. This can create both a life safety concern as well as fire hazard.

Due to the age and it being unknown if all dwelling unit panels have S-type fuses installed, AEI recommends inspection of all dwelling unit panels to assure that S-type fuses are in place. (Critical Repair)

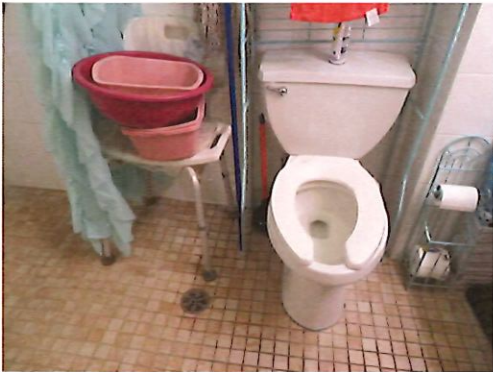
UFAS Unit 22 Two Bedroom One Bathroom
(occupied): Bathroom No Grab Bars (Critical
Repair)

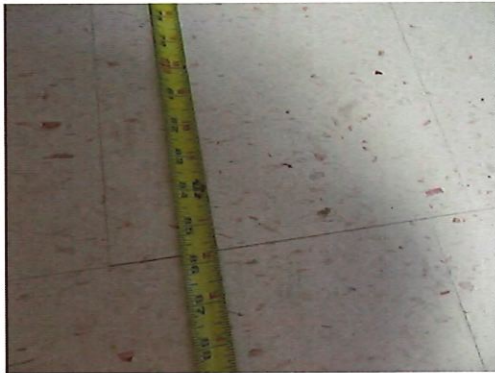
UFAS Unit 103 Two Bedroom One Bathroom (occupied): Kitchen Width

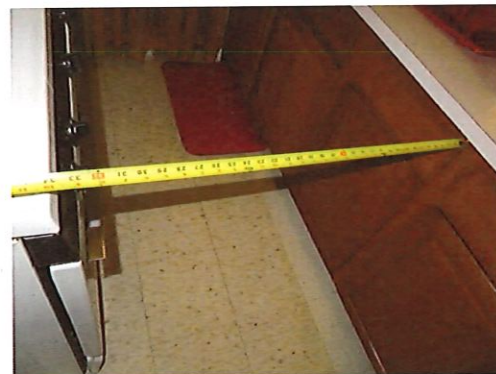
UFAS Unit 22 Two Bedroom One Bathroom (occupied): Kitchen Distance Between Cabinets

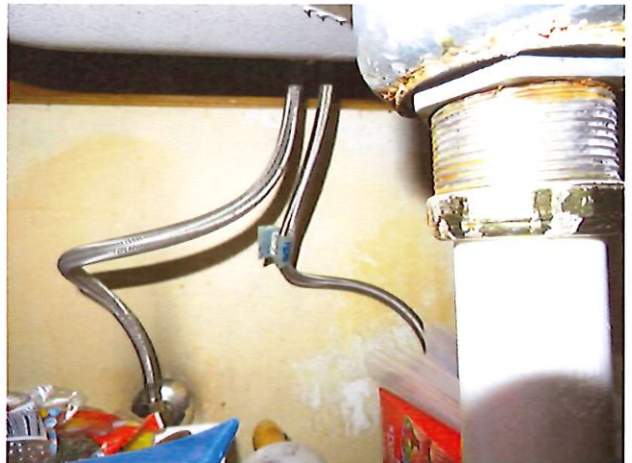
8. UFAS Unit 103 Two Bedroom One Bathroom (occupied): Sink Under Counter Not Prepped For Wheelchair (Critical Repair)

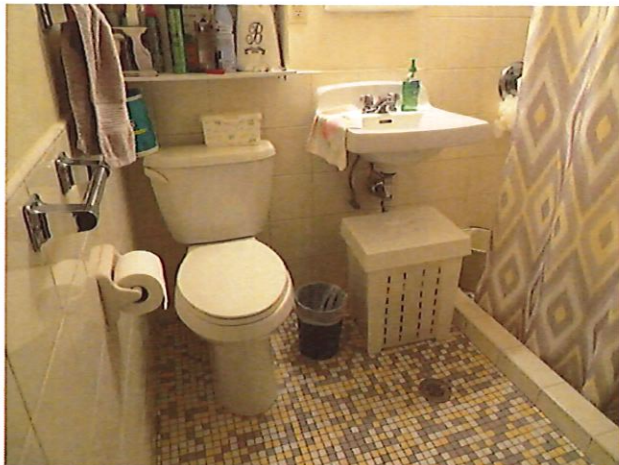
11. UFAS Unit 103 Two Bedroom One Bathroom (occupied): Bathroom Needs Grab Bars (Critical Repair)

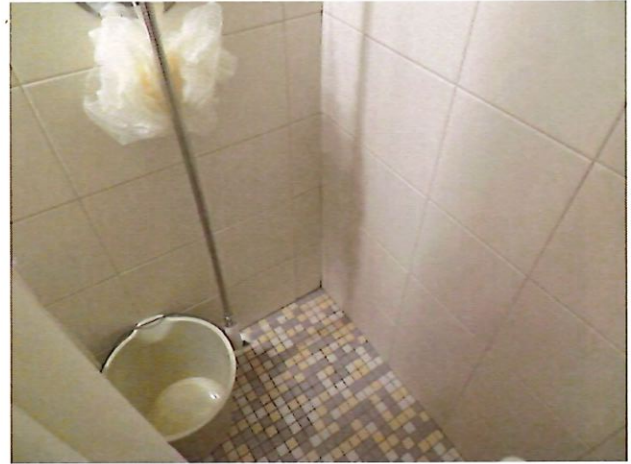
14. UFAS Unit 103 Two Bedroom One Bathroom (occupied): Shower Hose Broken (Critical Repair)

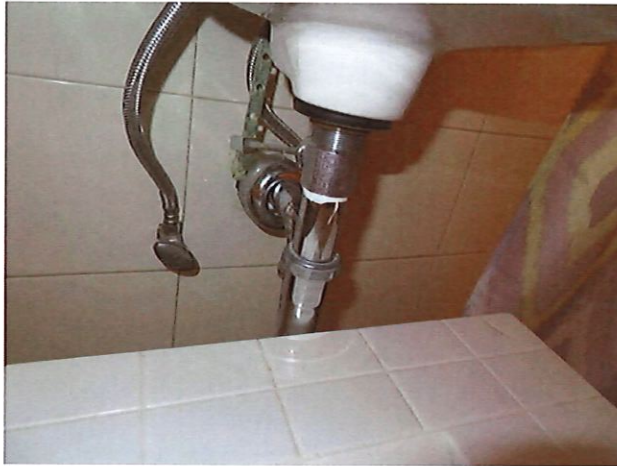
17. UFAS Unit 103 Two Bedroom One Bathroom (occupied): Bathroom Sink Needs Scald and Abrasion (Critical Repair)

- The designated handicapped dwelling unit bathrooms were observed without scald and abrasion wrapping installed at the sink piping, which is required in order to comply with UFAS and for the safety of the residents. (Critical Repair)
- The designated UFAS units bathroom and bedroom doors were equipped with knob hardware. In order to comply with UFAS, levered hardware is required to be installed. (Critical Repair)
- Concrete flatwork was observed adjacent to the play area, but no pavement was provided directly connecting to the play area, which is required in order to comply with UFAS. (Critical Repair)

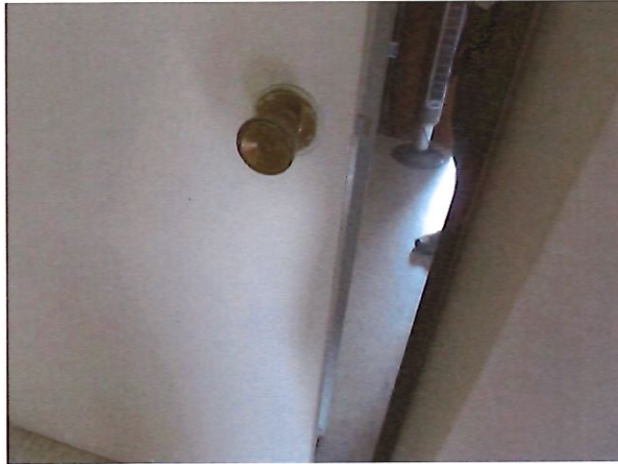
21. UFAS Unit 103 Two Bedroom One Bathroom (occupied): Bedroom Does Not Have Levered Hardware (Critical Repair)

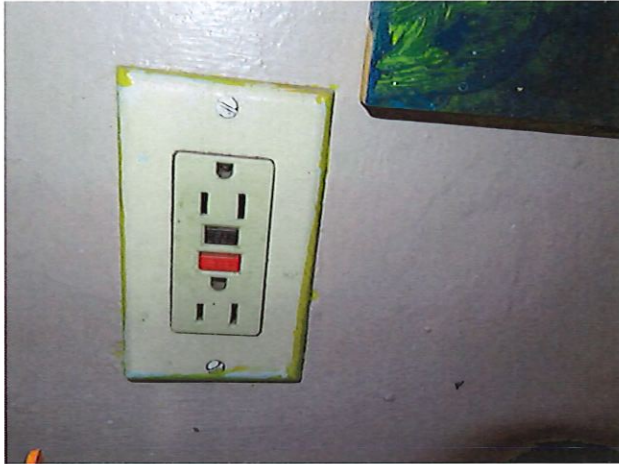
48. Unit 82 Two Bedroom One Bathroom (occupied):
Bathroom

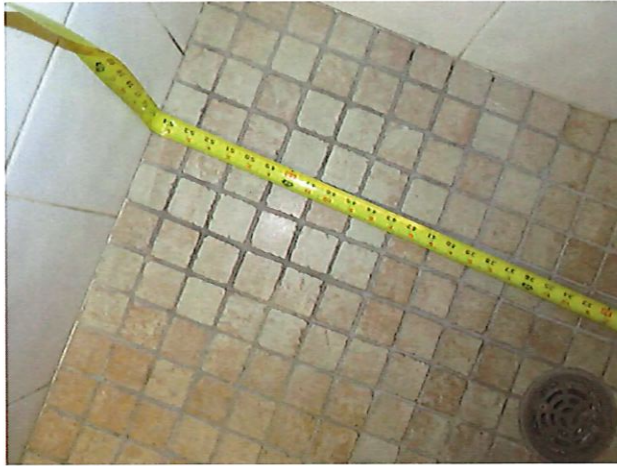
64. UFAS Unit 22 Two Bedroom One Bathroom (occupied): Shower Length

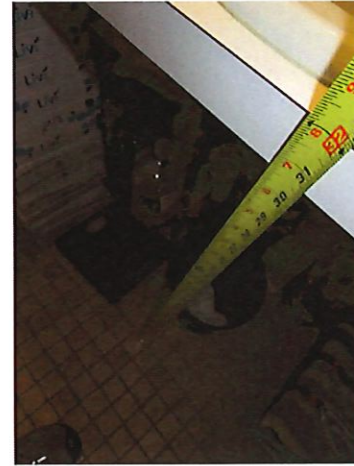
65. UFAS Unit 22 Two Bedroom One Bathroom (occupied): Shower Width

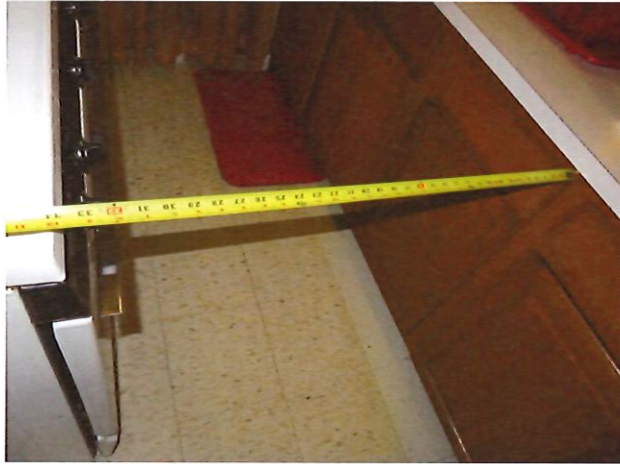
68. UFAS Unit 22 Two Bedroom One Bathroom (occupied): Kitchen Length
