HUD MAP CAPITAL NEEDS ASSESSMENT

Franklin Towers
50 White Street
Tarrytown, New York 10591

AEI Project No. 419363
Site Inspection Date: 3/10/2020

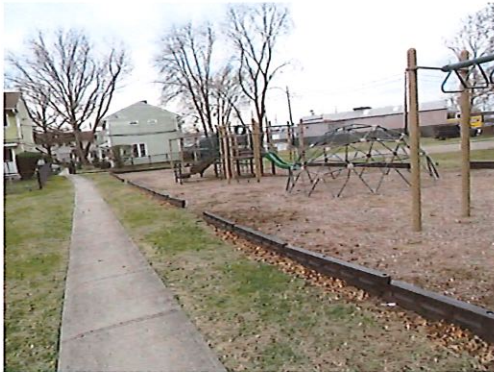
South Topography

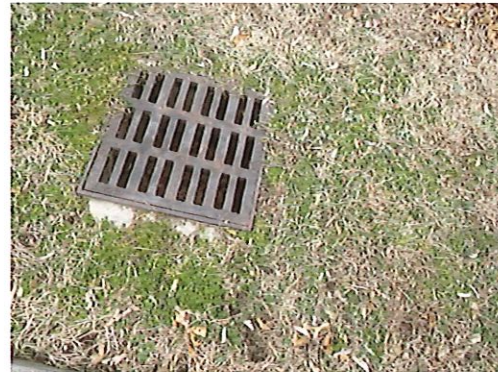
Landscape Storm Drain

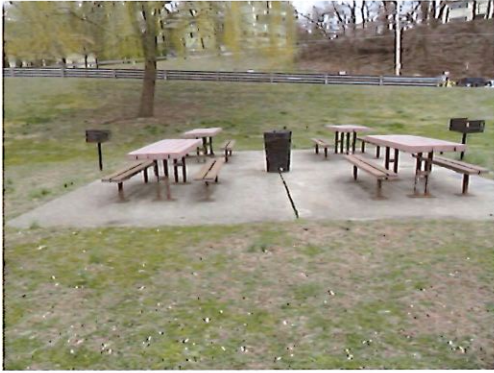
Topography Facing North

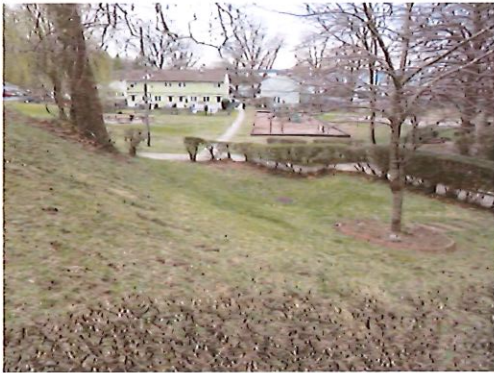
Site Topography and Landscaping

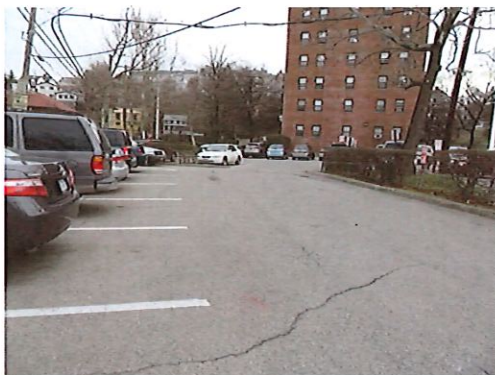
Parking Lot

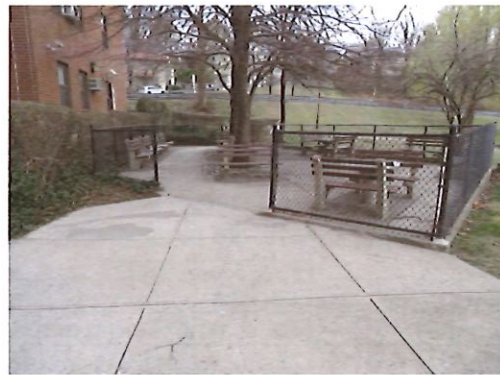
Outdoor Seating Enclosure

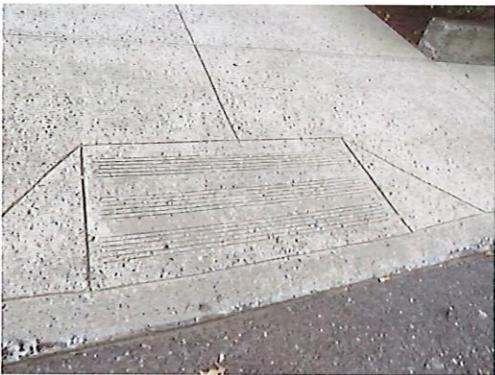
Concrete Ramp

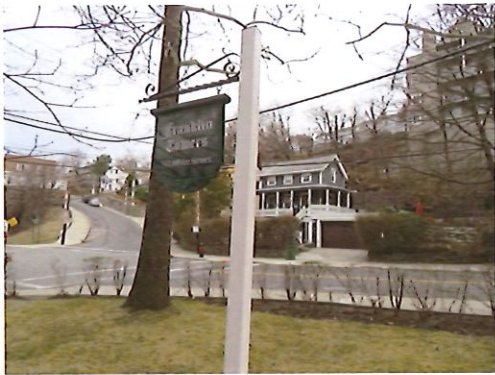
Exterior Signage

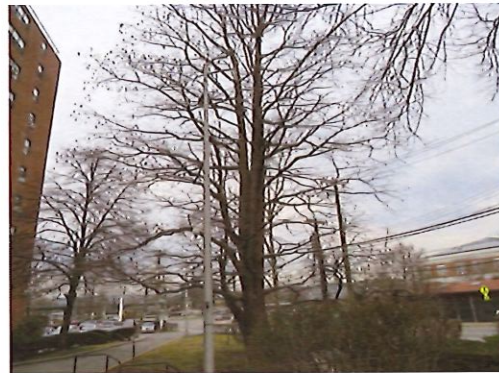
Exterior Lighting

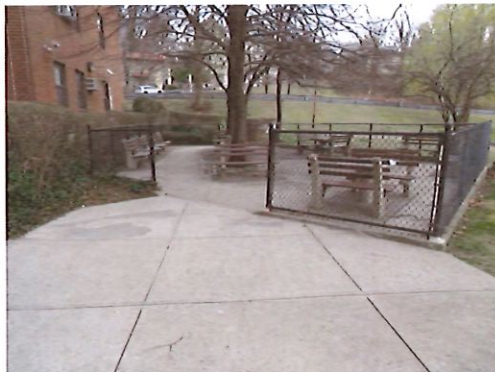
Fencing Around Patio Area

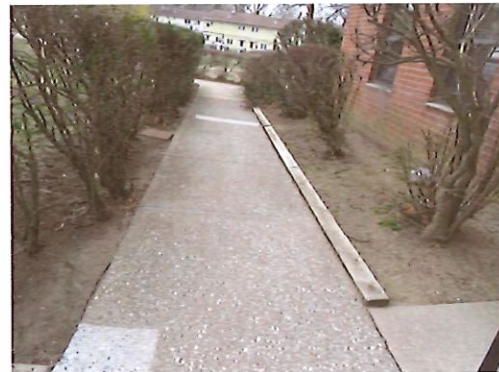
Bare Ground

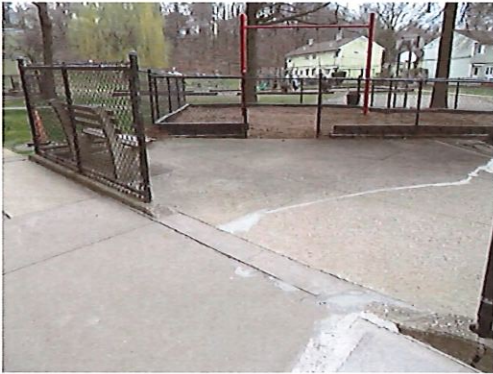
Outdoor Playground

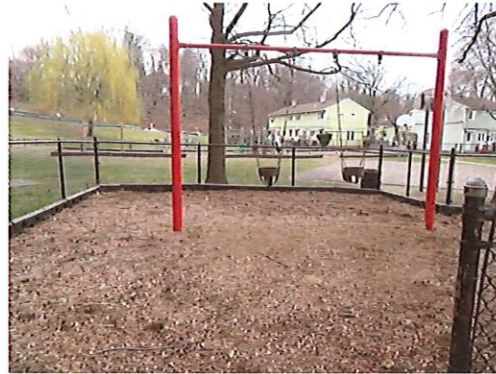
Playground Swings

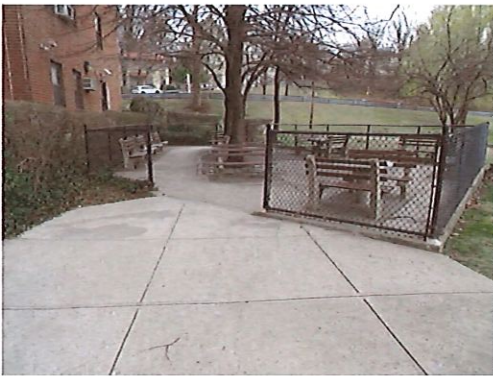
Outdoor Seating Enclosure

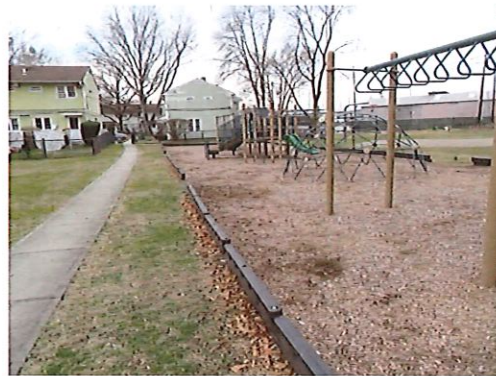
Outdoor Playground

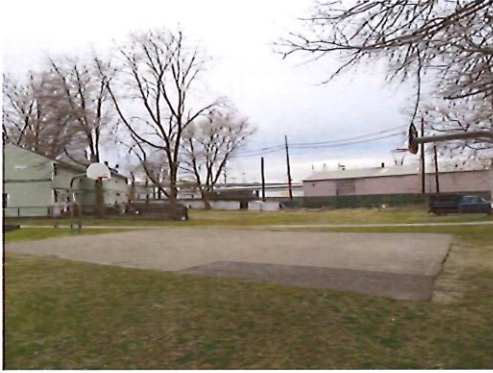
Basketball Court

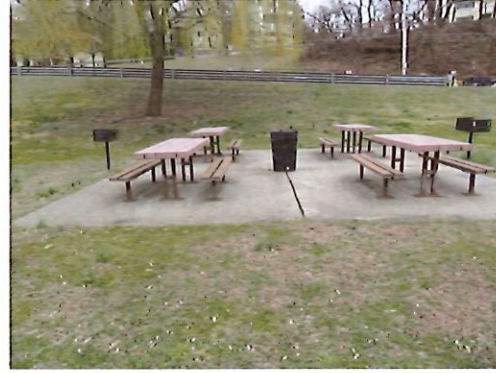
Outdoor Picnic Area

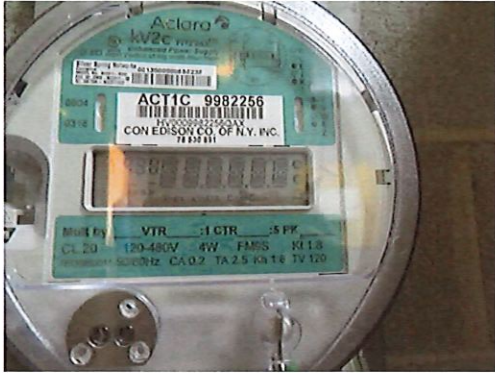
Electric Meter

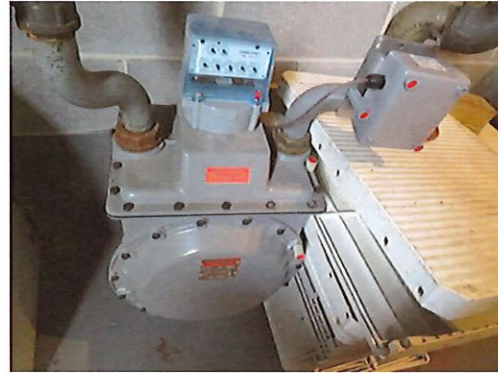
Gas Meter

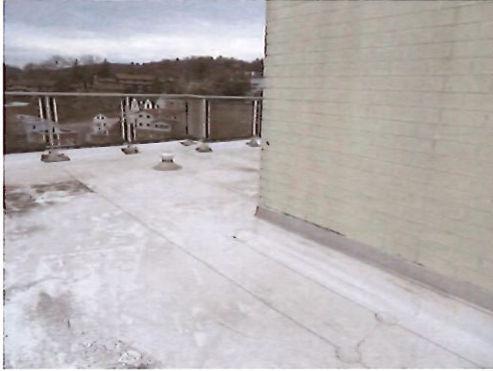
Roof flashing appeared to be in overall good

Roof Flashing

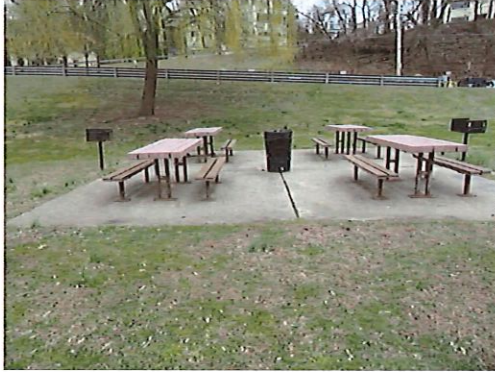
Outdoor Picnic Area

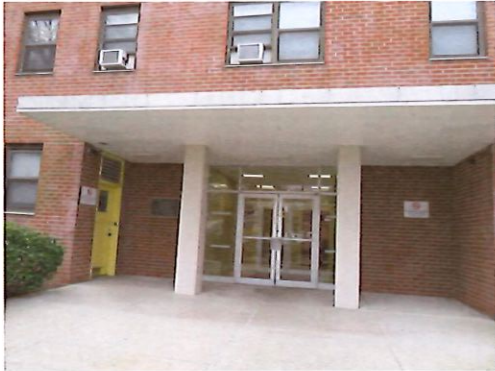
Main Entrance

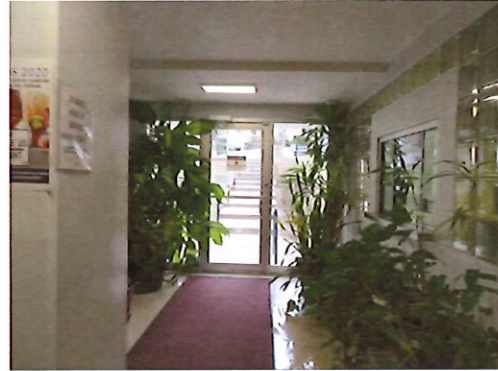
Leasing Office Lobby

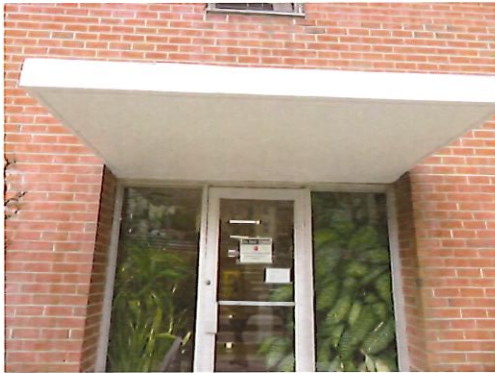
Leasing Office Entrance

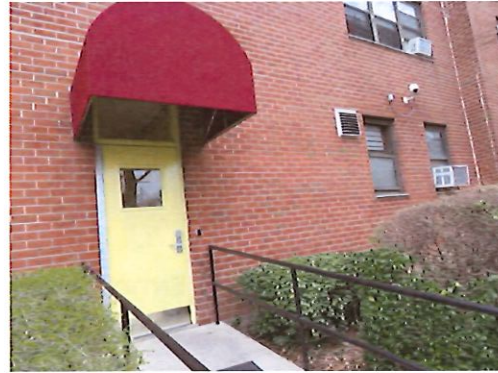
Back Door

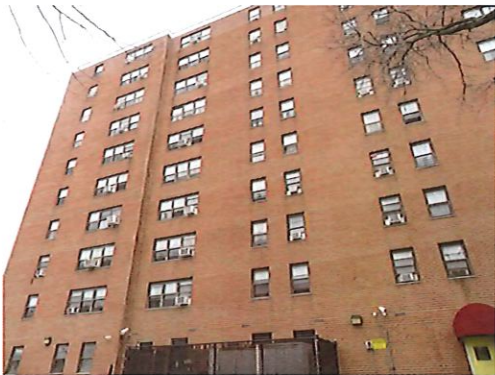
Typical windows

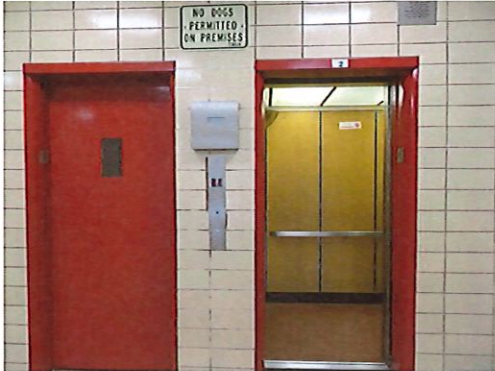
Elevators

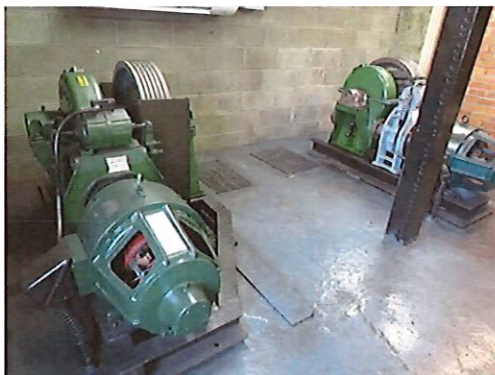
Based on the RUL of the elevator finishes and machinery, replacement is anticipated during the reserve.

Elevator Brakes/Machinery

According to Property Management, planned improvements include turnkey upgrades to elevators, with an estimated budget of \$600,000. (Non-Critical Repair)

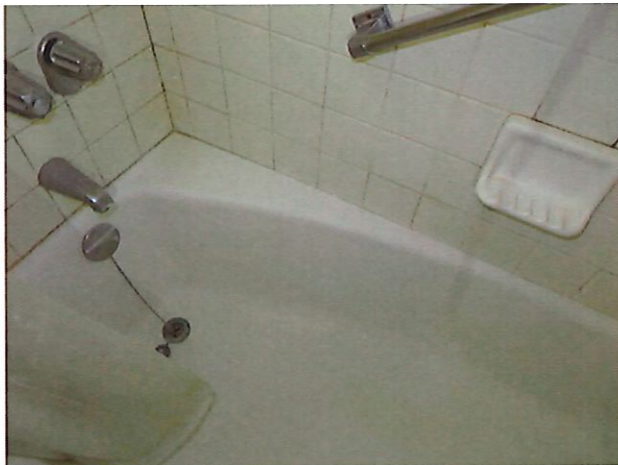
34. Unit 108 One Bedroom One Bathroom (occupied): Bathroom

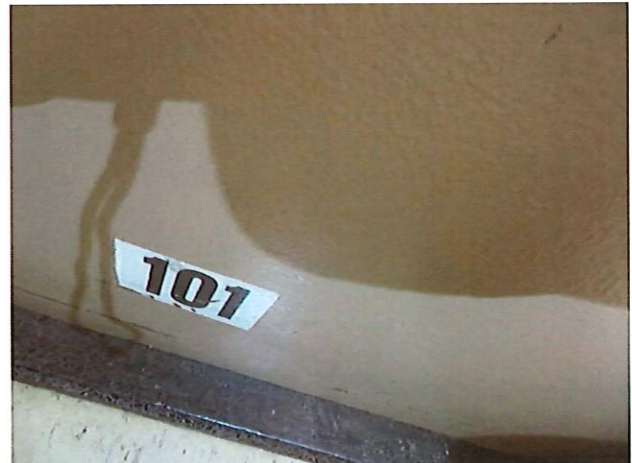
35. Unit 108 One Bedroom One Bathroom (occupied): Bathtub

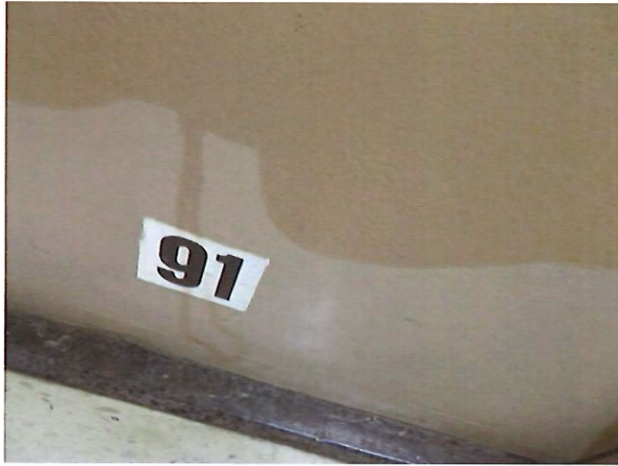
36. Unit 101 Three Bedroom One Bathroom (occupied): Front Door

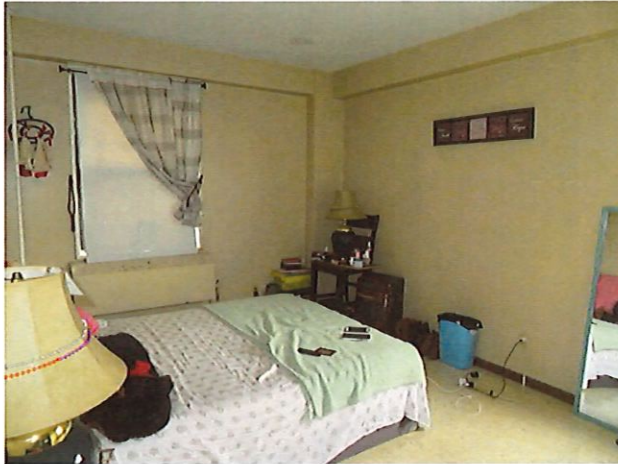
40. Unit 91 Three Bedroom One Bathroom (occupied): Bedroom One

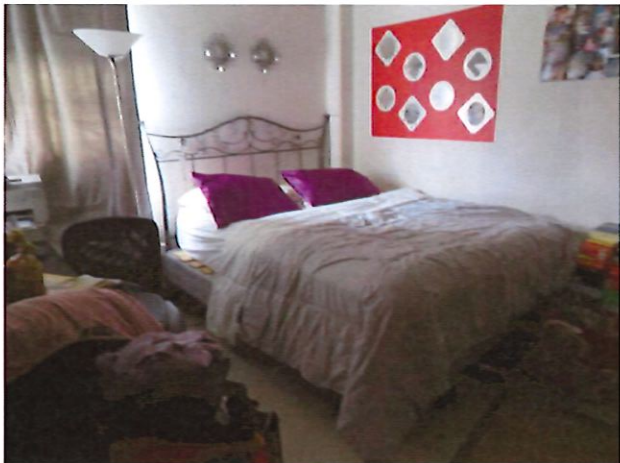
46. Unit 82 Two Bedroom One Bathroom (occupied):
Bedroom One
